# INSPECTION REPORT

For the Property at:  
**321 TYPICAL STREET**  
TORONTO, ON

Prepared for: VALUED CLIENT  
Inspection Date: Tuesday, October 2, 2012  
Prepared by: Lisa Simkins

Report No. 1016, v.3

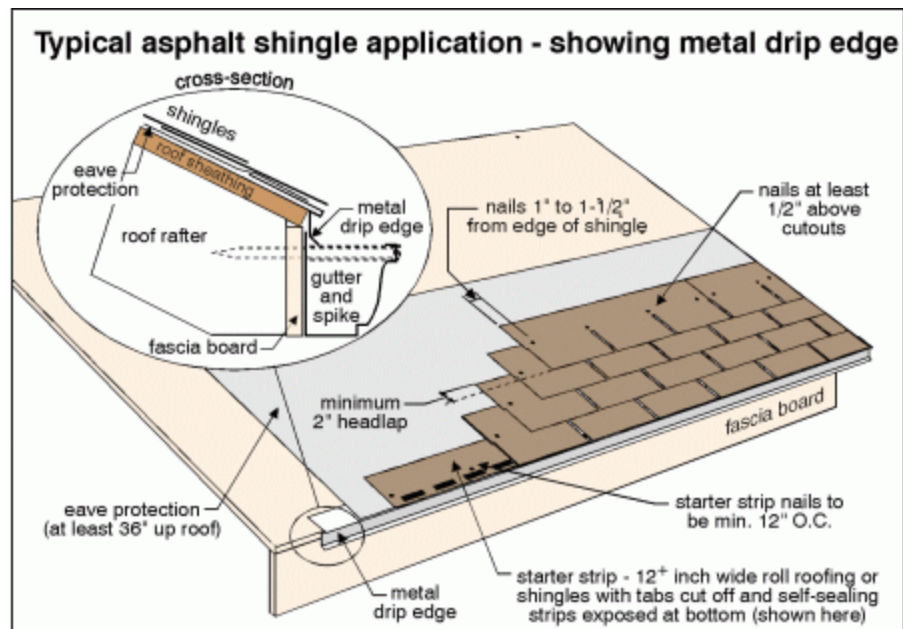
#### 1. Condition: • [Old, worn out](#)

**Implication(s):** Chance of water damage to contents, finishes and/or structure

**Task:** Replace

**Time:** Immediate

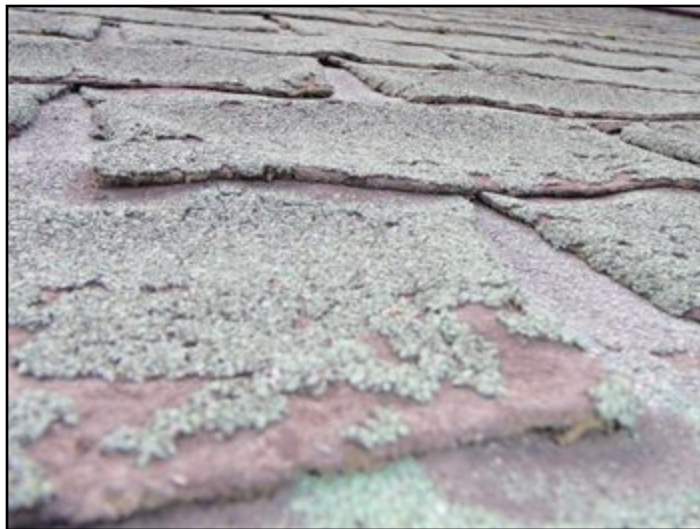
*Old, worn out at front*

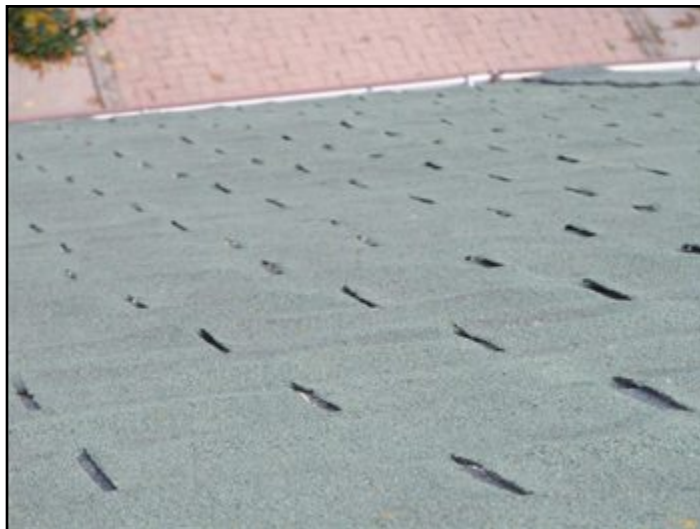
**2. Condition:** • [Cupping, curling, clawing](#)

**Implication(s):** Chance of water damage to contents, finishes and/or structure

*Curling shingles on front of peak*

**Task:** Replace

**Time:** Immediate

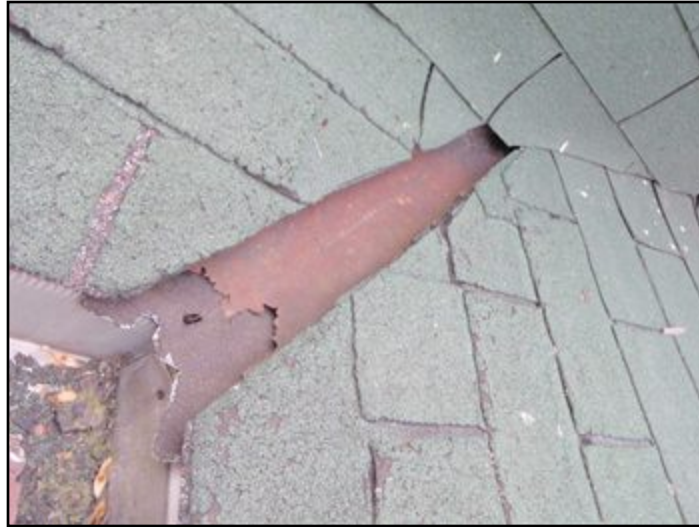
**3. Condition:** • [Rust](#)

**Implication(s):** Chance of water damage to contents, finishes and/or structure

*Rust*

**Task:** Replace

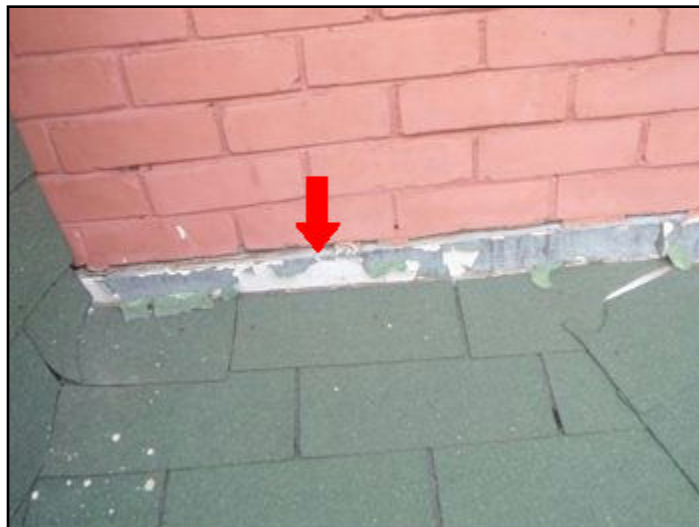
### **4. Condition:** • [Damage, loose, open seams, patched](#)

**Implication(s):** Chance of water damage to contents, finishes and/or structure

*opened seam of flashing*

**Task:** Repair

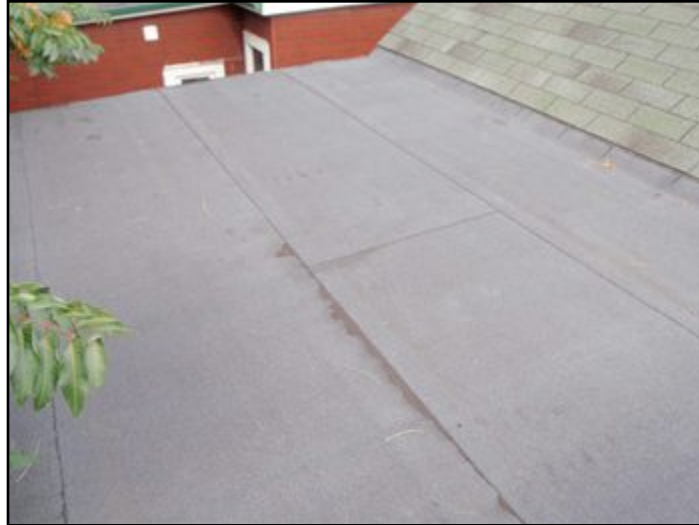
**5. Condition:** • Tree overhang - trim back

**Implication(s):** Trees drop debris which can promote moisture retention, and overhanging tree branches can rub on roofing in the wind, causing wear and tear.

*Roll roofing*

**Task:** Correct

**Time:** Immediate

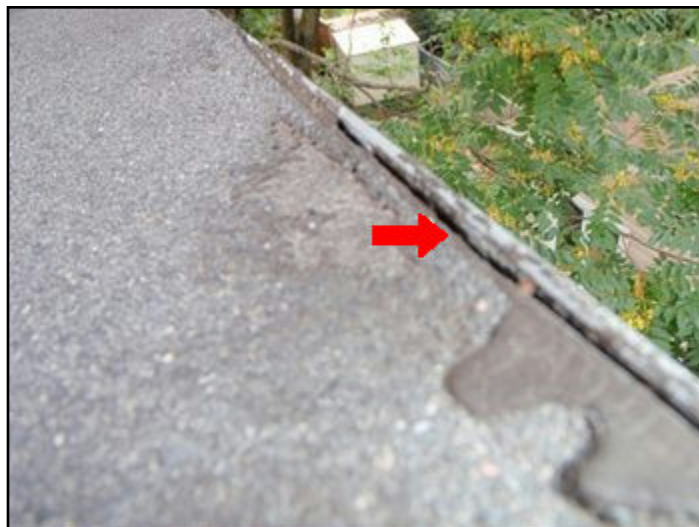
**6. Condition:** • [Openings at seams or flashings](#)

**Implication(s):** Chance of water damage to contents, finishes and/or structure

*Openings at flashing of flat roof*

**Task:** Repair

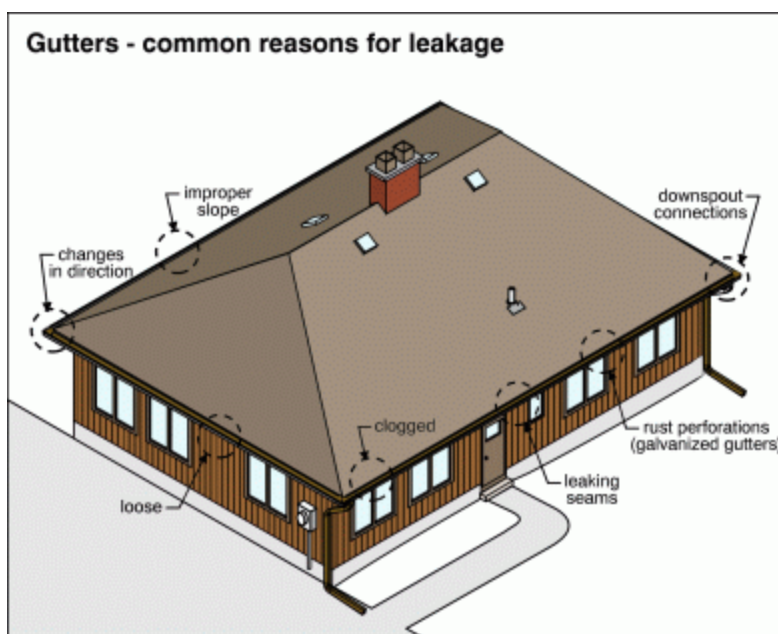
7. Condition: • [Clogged](#)

Implication(s): Chance of water damage to contents, finishes and/or structure

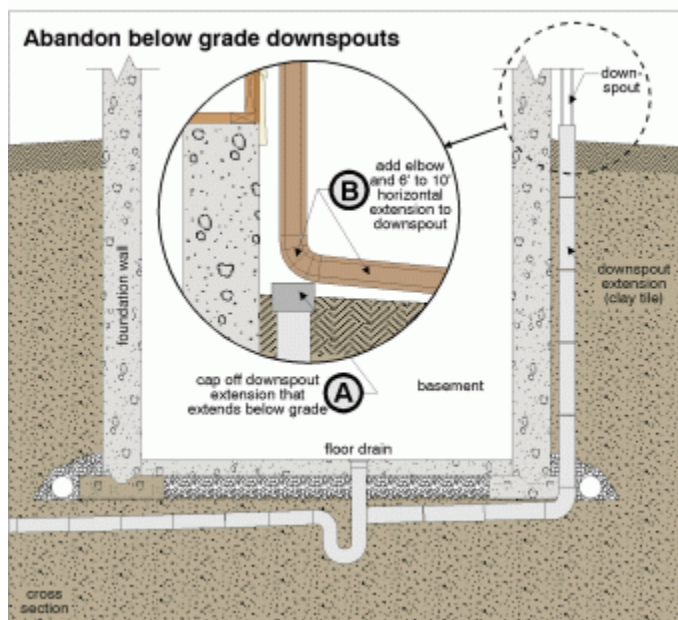
### 8. Condition: • [Downspouts discharging below grade](#)

Potential source of basement leakage if underground drains back up.

**Implication(s):** Chance of water damage to contents, finishes and/or structure

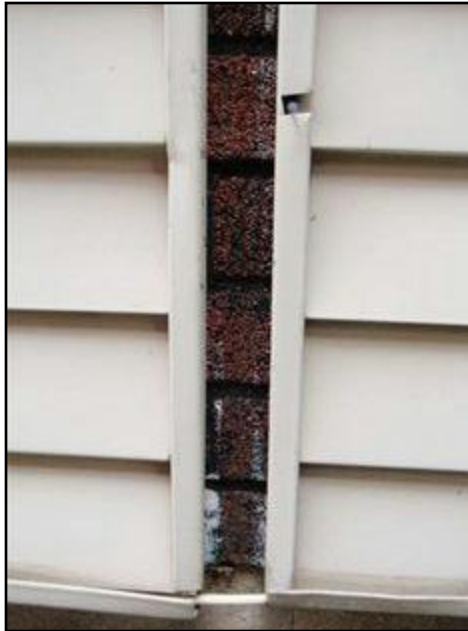
**9. Condition:** • Gap

*Gap in siding*

**Task:** Improve

**Time:** Immediate

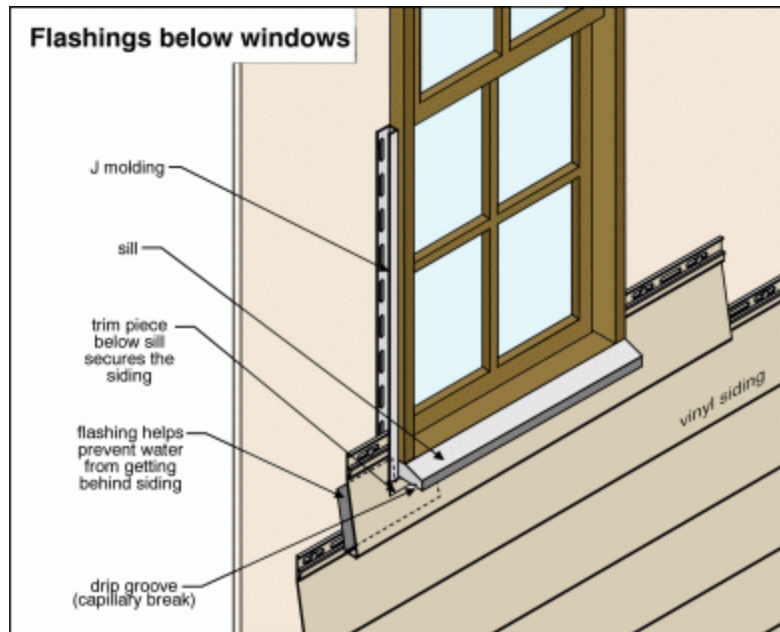
**10. Condition:** • [Flashing and caulking defects](#)

*open joints around frames*

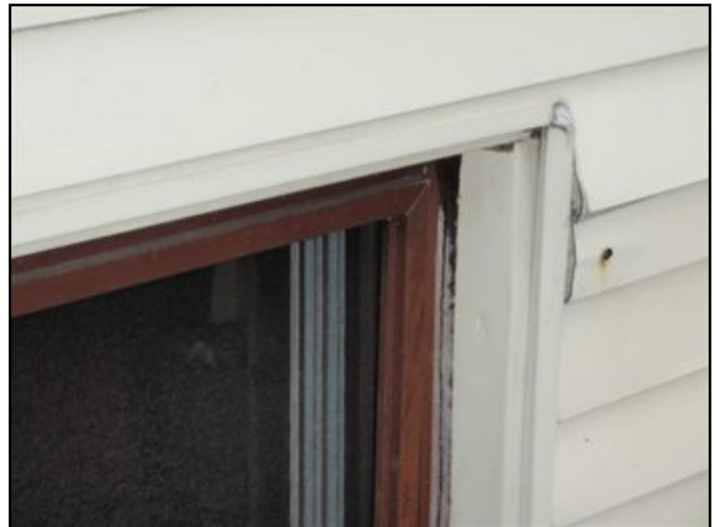
*unsealed areas*

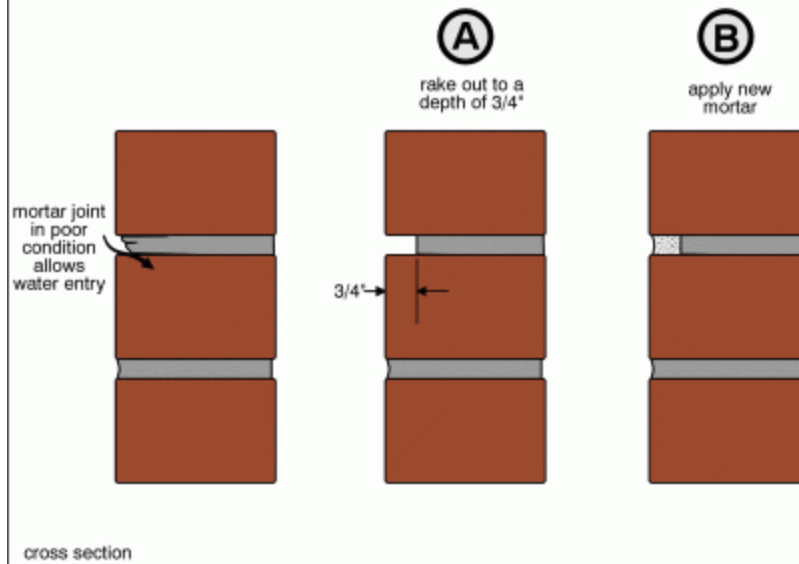
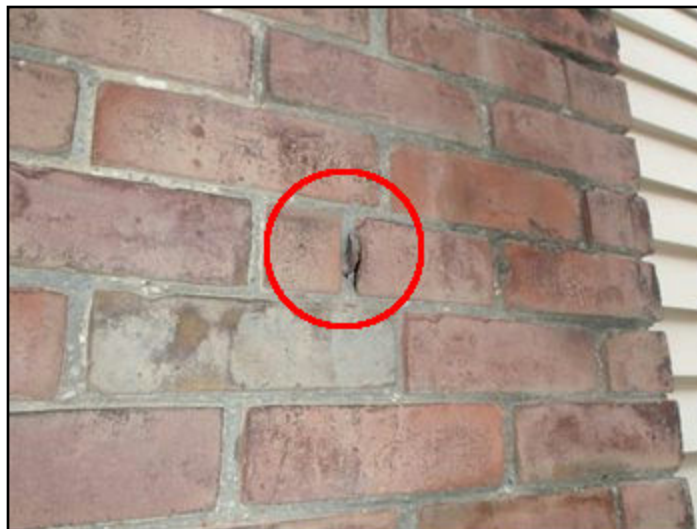
### **11. Condition:** • [Mortar deterioration](#)

Small areas of mortar deterioration.

*Typical mortar deterioration*

**Task:** Repair (tuck pointing)

**Time:** Yearly inspection by owner and tuck pointing by qualified mason

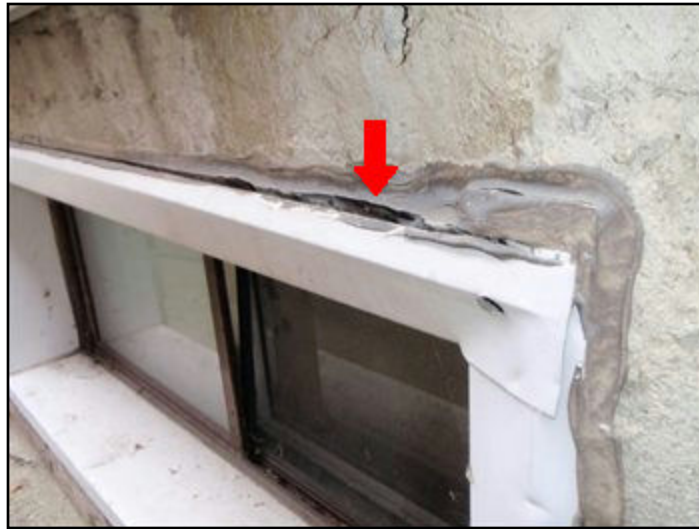
**12. Condition:** • [Caulking loose, missing or deteriorated](#)

**Implication(s):** Chance of water damage to contents, finishes and/or structure | Increased heating and cooling costs

*Caulking loose, missing or deteriorated*

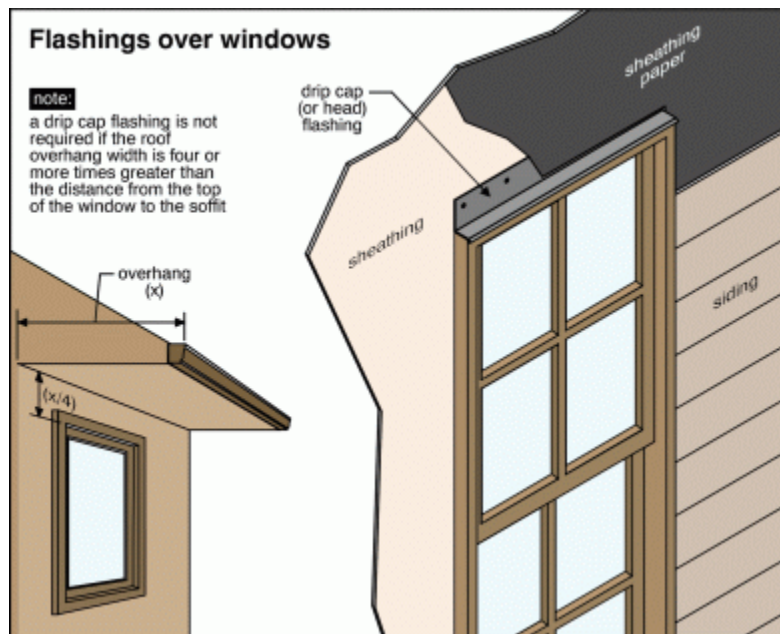
13. Condition: • [Missing](#)

Implication(s): Chance of water damage to contents, finishes and/or structure

Task: Provide

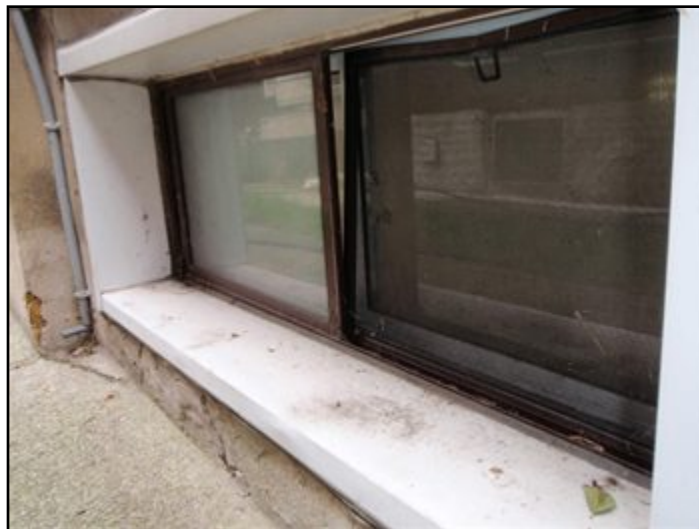
**14. Condition:** • screen out of place

*basement window*

**Task:** Repair

**Time:** Regular maintenance

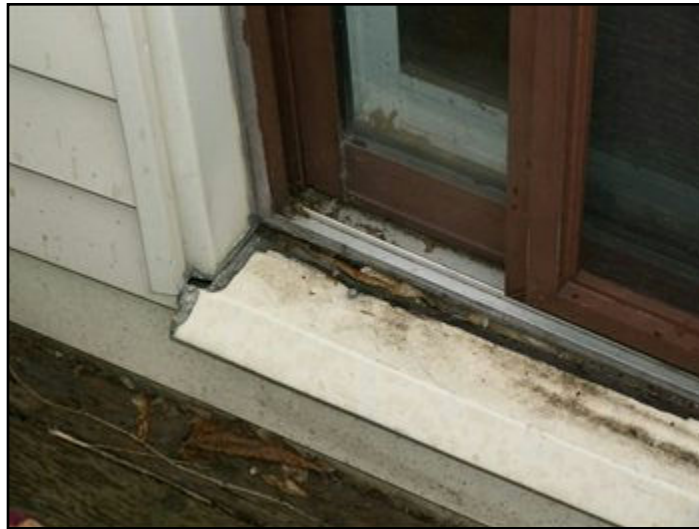
**16. Condition:** • [Caulking missing, deteriorated or loose](#)

**Implication(s):** Chance of damage to finishes and structure

*sliding door trim in poor condition*

**Task:** Repair/seal

**Time:** immediate

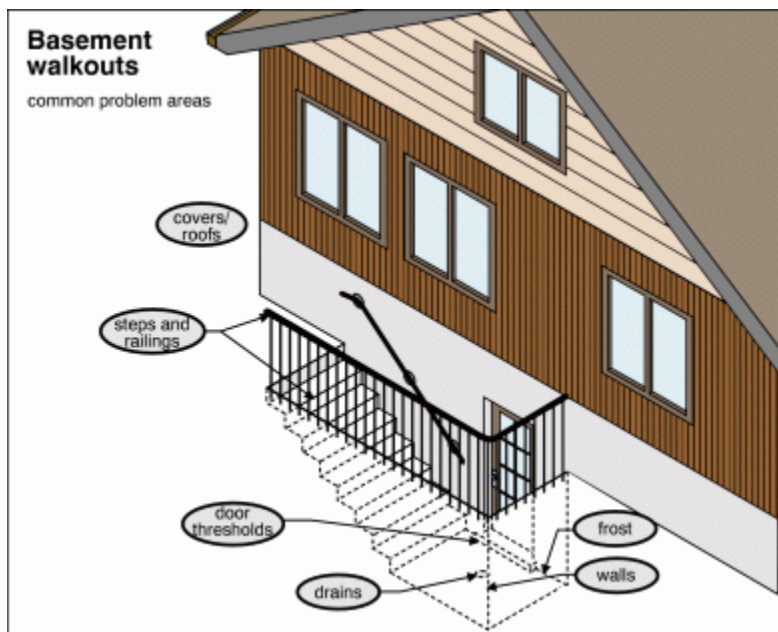
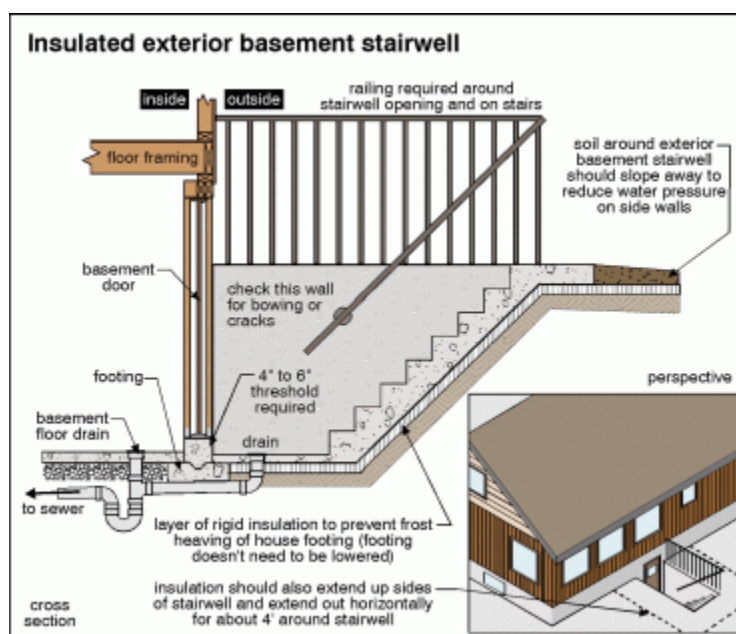
## 20. Condition: • [Drains missing, clogged or undersized](#)

Owner reports inadequate drainage.

**Implication(s):** Chance of water damage to contents, finishes and/or structure

**Task:** Further evaluation by drain specialist.

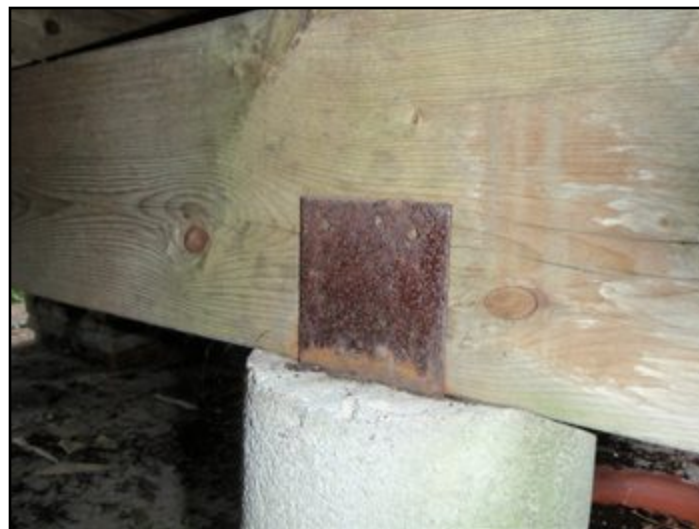
**22. Condition:** • Beam not secured to bracket

*Fastening missing*

**Task:** Improve

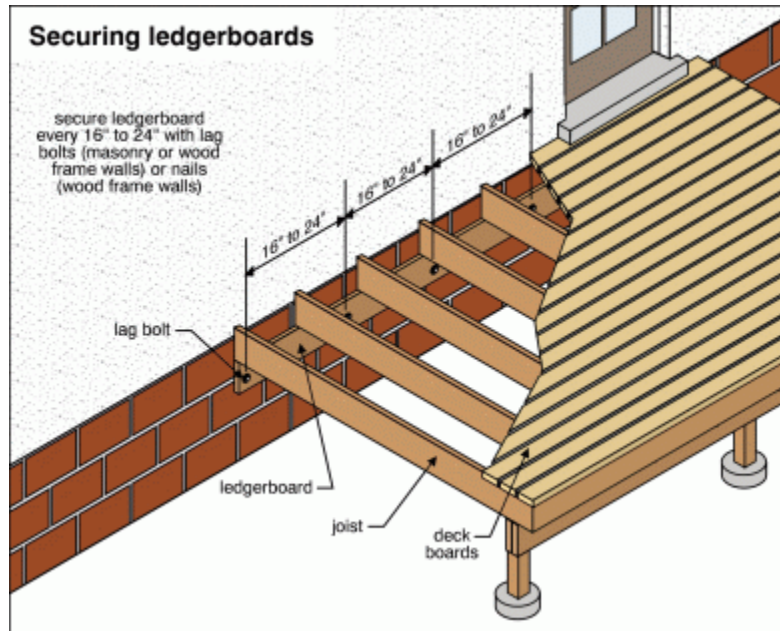
West side of deck

### 23. Condition: • [Ledgerboard problems](#)

**Implication(s):** Weakened structure | Chance of movement

**Task:** Further evaluation

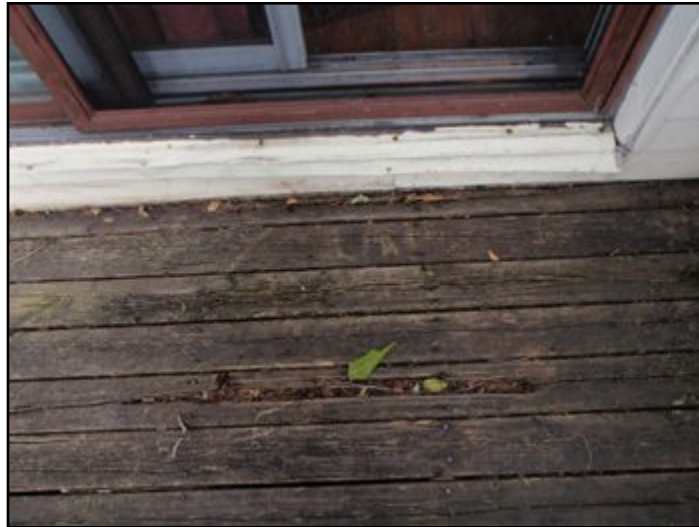
**24. Condition:** • [Rot or insect damage](#)

*Rot damage in deck*

**Task:** Replace deck floor boards

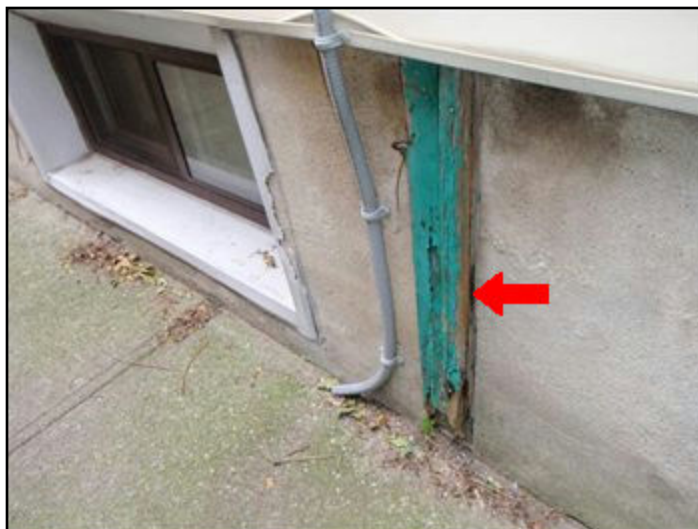
**28. Condition:** • [Wood/soil contact](#)

Remains of wood post in foundation at fence line. This makes structure more vulnerable to water and pests.

*Wood/soil contact*

**Task:** Repair. ie. remove external portion of wood and reseal wall

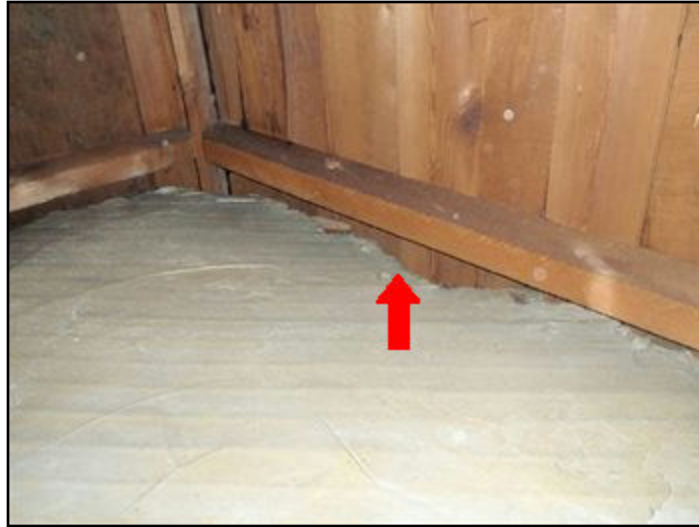
**29. Condition:** • [Incomplete in attic](#)

**Implication(s):** Increased fire hazard

*example of gaps in firewall of attic*

**Task:** Improvement recommended

**Time:** Immediate

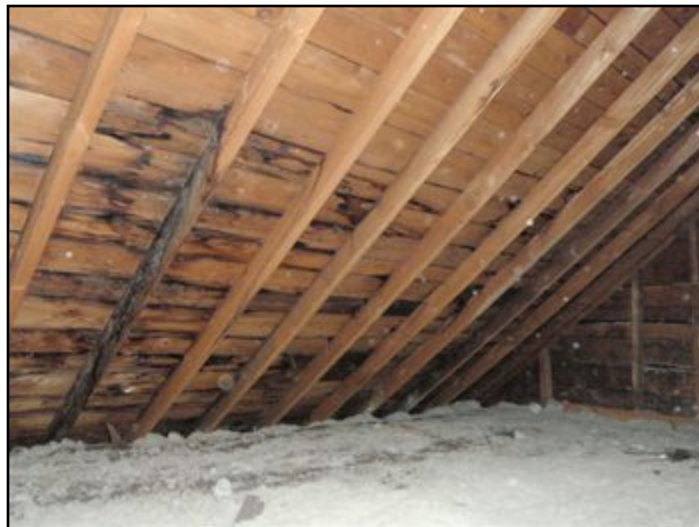
### **30. Condition:** • [Water stains](#)

This may have occurred before rear roof was redone, however it is good practice to inspect yearly and during heavy rainfalls to determine if staining is increasing or wood is wet

*Water stains*

**Task:** Monitor

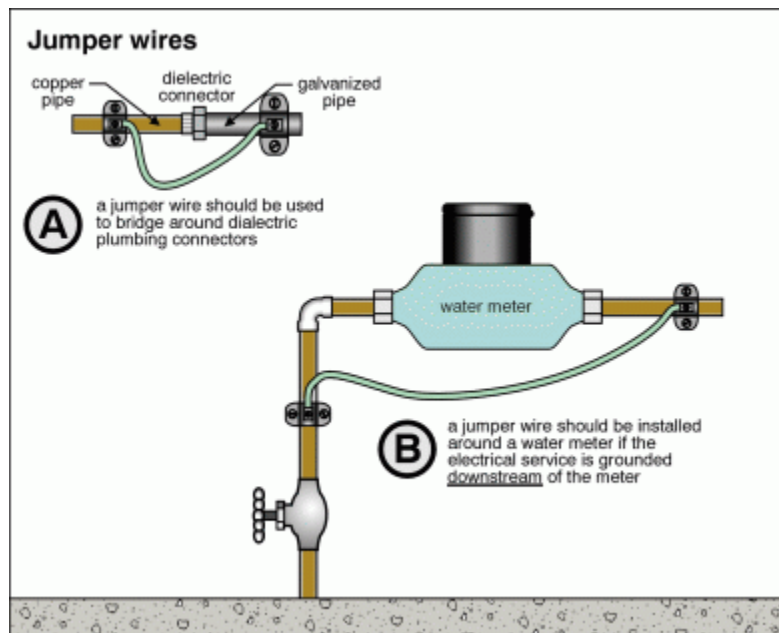
**31. Condition:** • [No jumper for meters and valves](#)

**Task:** Provide

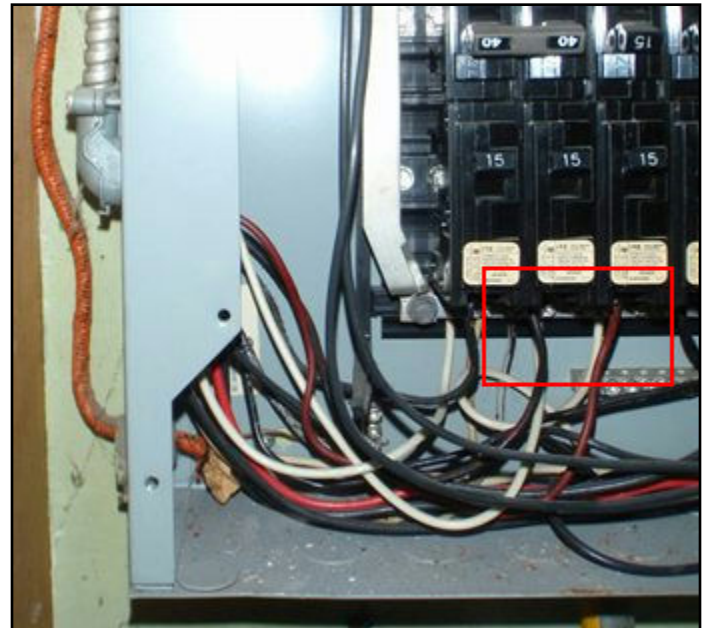
**33. Condition:** • Suspect

**Implication(s):** Safety - wiring appears unusual and possibly discoloured from heat damage.

*Discoloured wires*

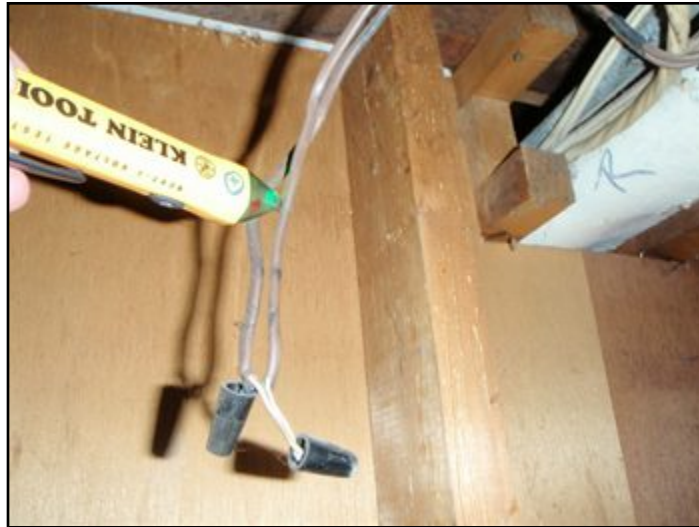
### **34. Condition:** • [Open splices](#)

**Implication(s):** Electric shock | Fire hazard

*Unprotected splice*

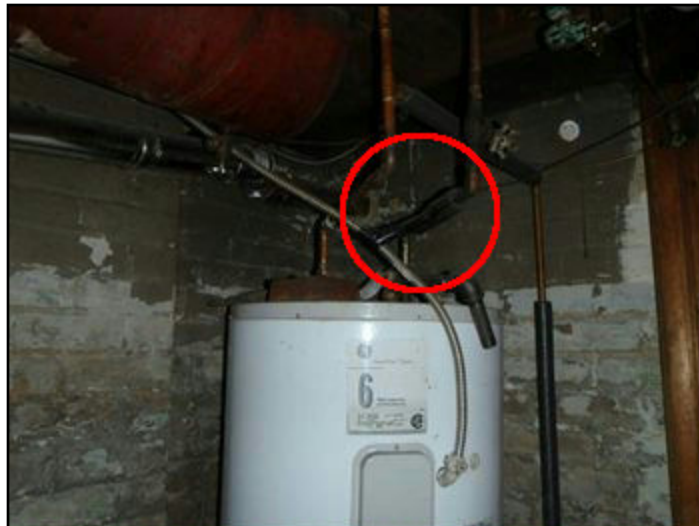
### **35. Condition:** • [Not well secured](#)

**Implication(s):** Electric shock | Fire hazard

*Not well secured*

**Task:** Remove electrical tape. Support cable appropriately

**Time:** Immediate

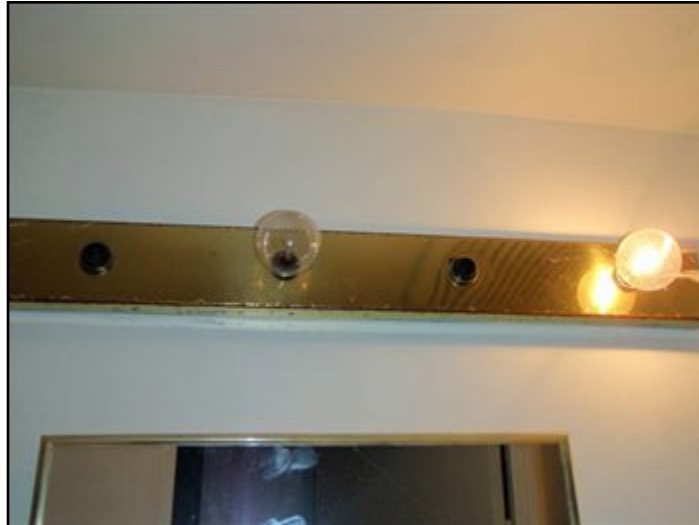
**37. Condition:** • [Inoperative](#)

A live light fixture with empty sockets is a shock hazard. Install light bulbs in all sockets. If fixture is too bright, use lower amperage bulbs.

*Inoperative and missing bulbs*

**Task:** Ensure all sockets are working. If they are not working there may be a wiring problem which could be a fire hazard. Repair by electrician. Fixture may need to be replaced.

**Time:** Immediate

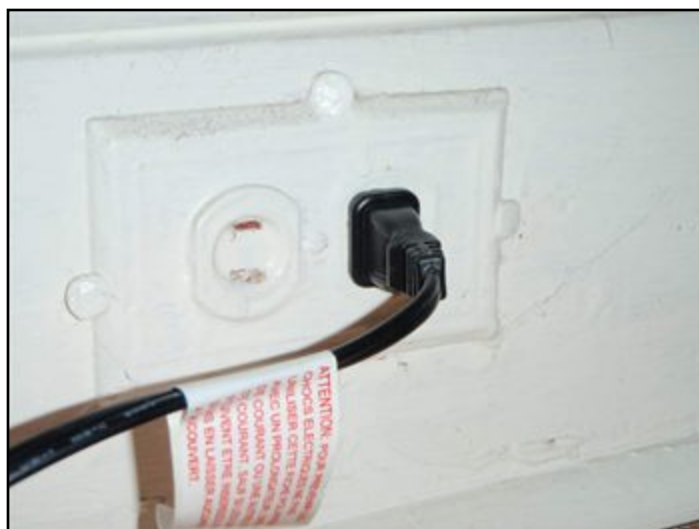
**39. Condition:** • [Ungrounded](#)**Location:** Various**Task:** Upgrade**Time:** Immediate

*Ungrounded 2 prong type*

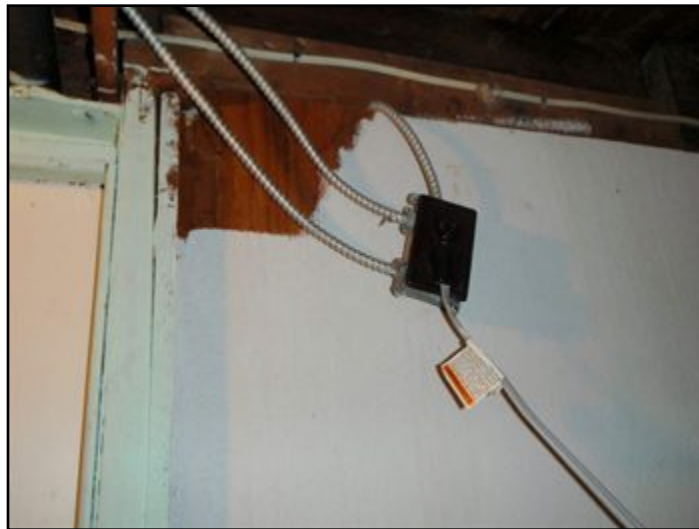
**41. Condition:** • [Loose](#)

*Loose receptacle*

**Task:** Mount securely

**Time:** Immediate

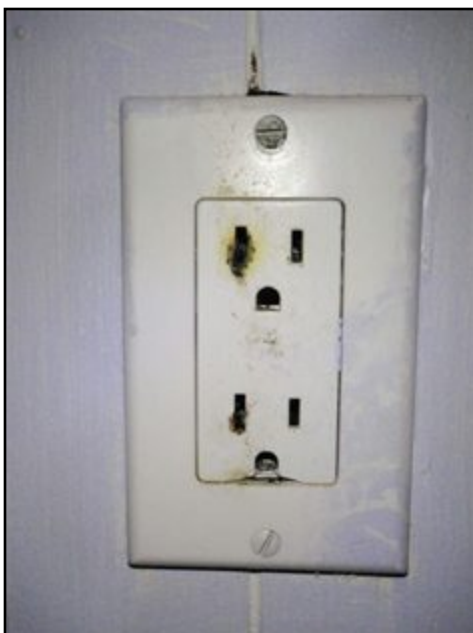
**42. Condition:** • [Overheating](#)

**Implication(s):** Fire hazard

*Evidence of electrical overheating*

**Task:** Further evaluation

**Time:** Immediate

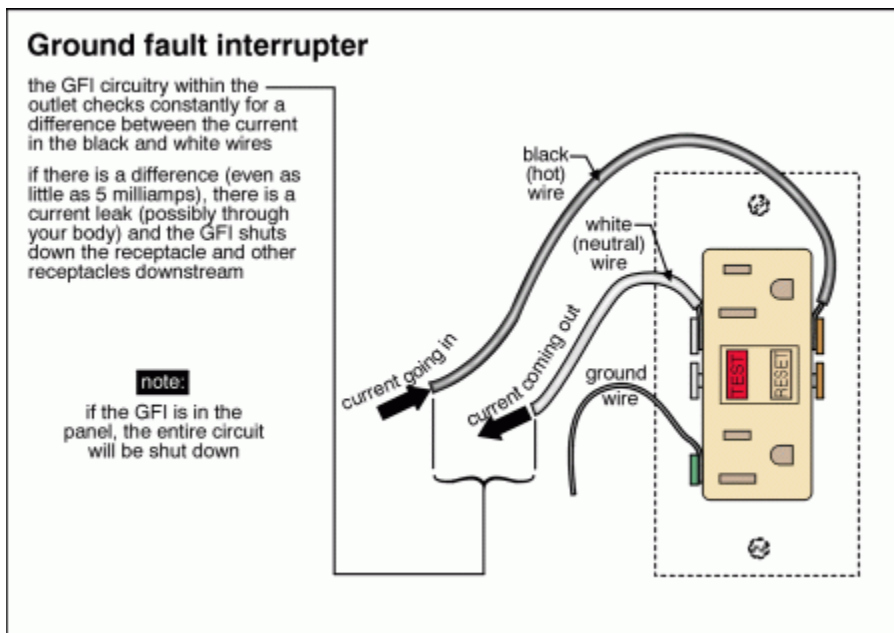
**43. Condition:** • [No GFI \(Ground Fault Interrupter\)](#)

**Task:** Upgrade

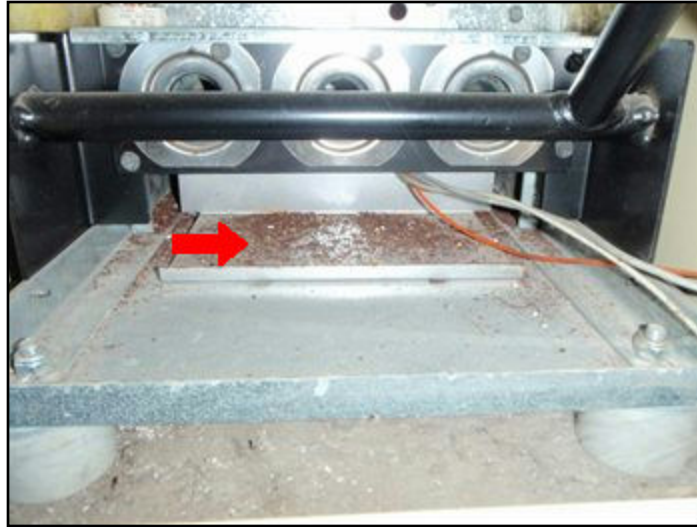
**47. Condition:** • [Rust](#)

Rust flakes indicate corrosion is occurring. Have boiler system evaluated by a qualified gas boiler technician

**Implication(s):** Shortened life expectancy of material | Material deterioration

*Rust below burners*

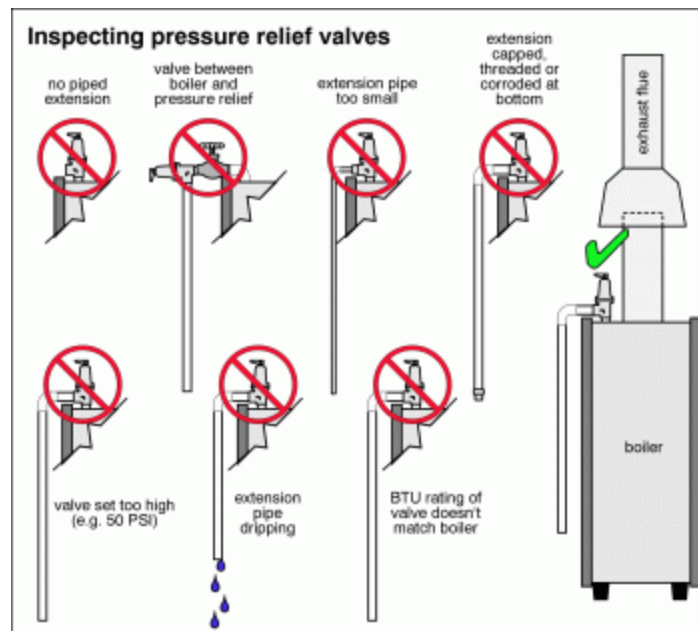
**48. Condition:** • [No pipe extension](#)

**Task:** Provide

**Time:** Immediate

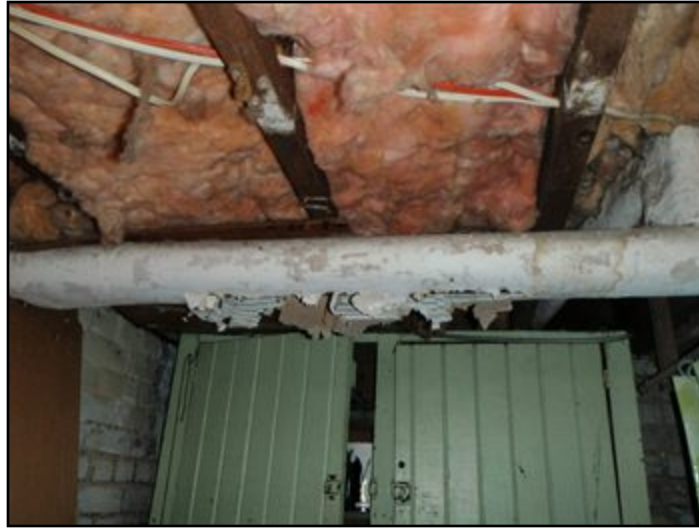
**49. Condition:** • [Pipe wrap damaged - possibly contains asbestos](#)

**Implication(s):** Asbestos in material is a health hazard if particles from wrapping become airborne.

*Boiler pipe wrap torn above cabinet*

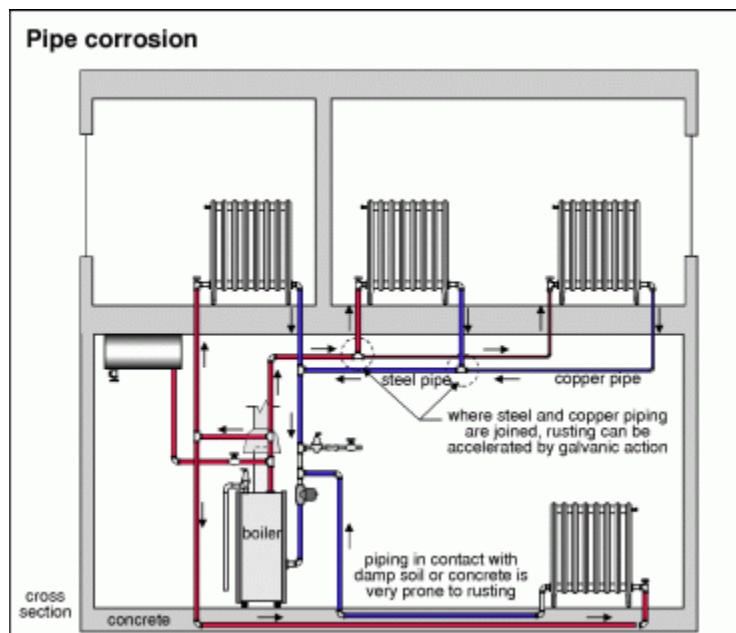
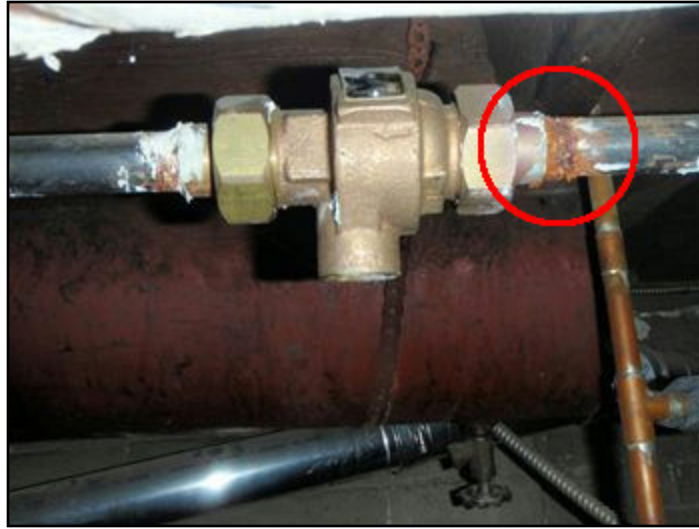
**50. Condition:** • [Rust](#)

Monitor piping for leaks.

Connections between cast iron piping and copper should have dielectric fittings to prevent corrosion by contact between dissimilar metals. Consult with plumbing and heating gas boiler specialist.

**Implication(s):** Chance of water damage to contents, finishes and/or structure | Increased heating costs | Reduced comfort

*Rust at boiler pipe connection*

**Task:** Further evaluation Monitor

**Time:** Less than 1 year

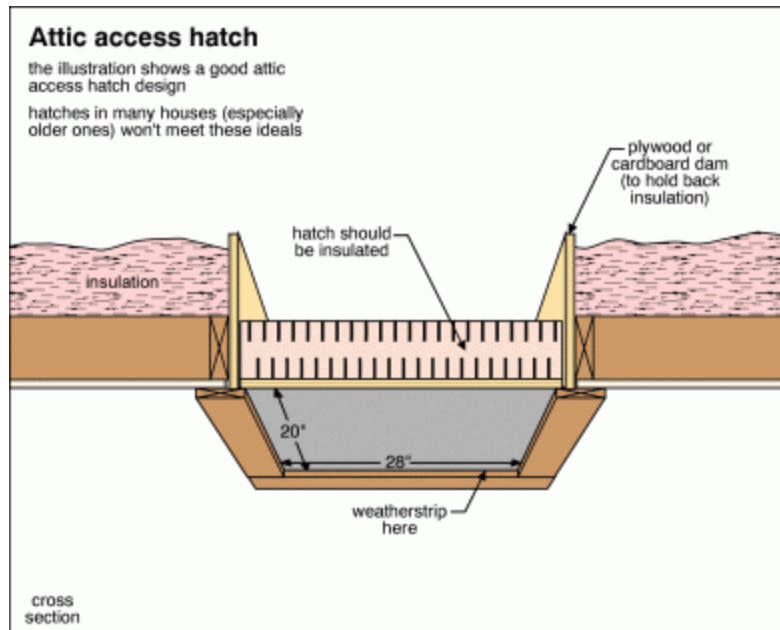
53. Condition: • [Not insulated and not weatherstripped](#)

Task: Improve

Time: Less than 1 year

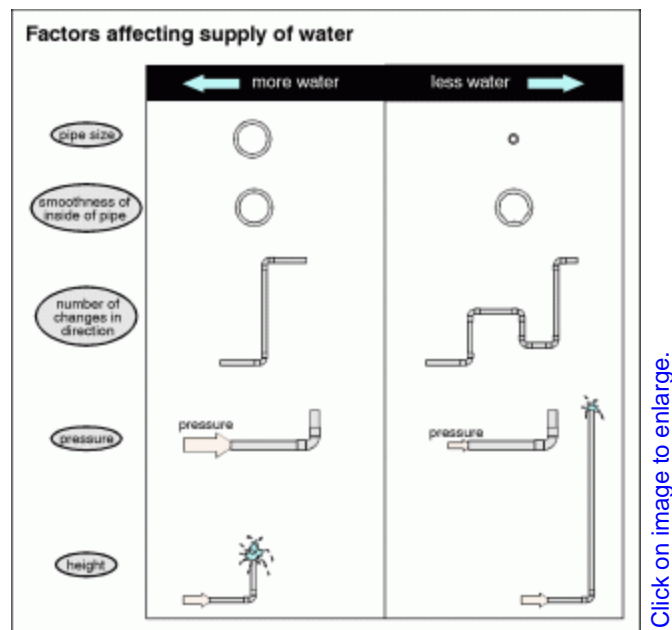
**55. Condition:** • [Poor pressure or flow](#)

rusting of galvanized pipe can greatly reduce water pressure and will eventually cause leaks as rust creates holes in the pipe walls

**Task:** Upgrade service piping to copper

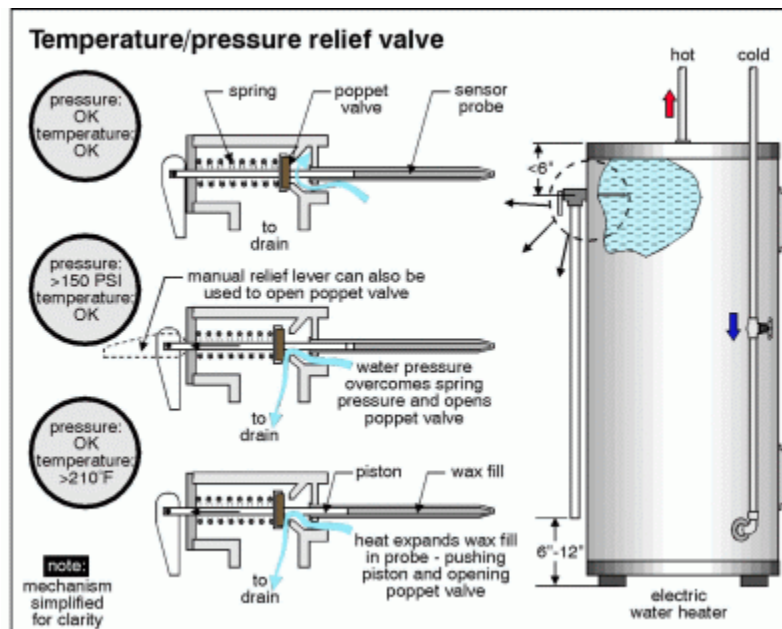
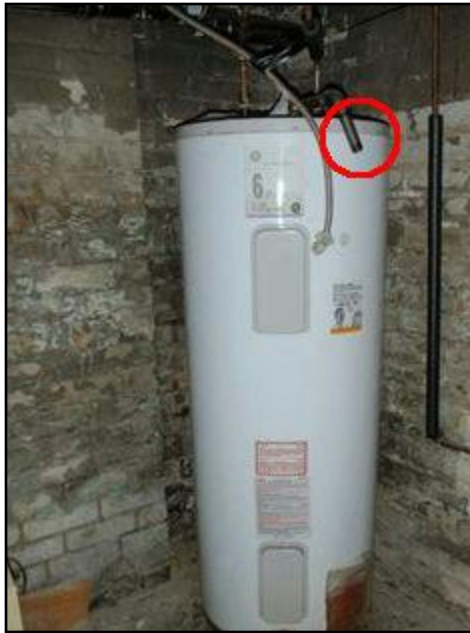
57. Condition: • [Discharge tube too short](#)

*Discharge tube too short*

Task: Provide - have plumber install correct pipe and do a service check on water heater.

Time: Immediate

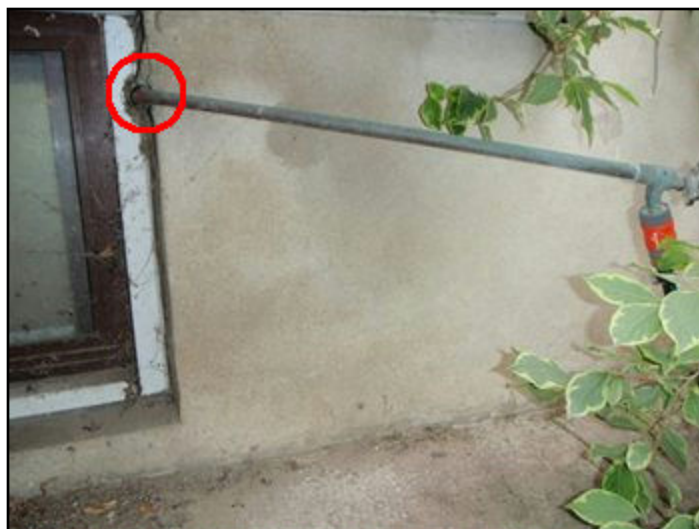
### **61. Condition:** • [Damage](#)

Have qualified plumber replace bent pipe. Avoid long unsupported pipe runs.

**Implication(s):** Leakage | Equipment inoperative

*Bent pipe going to outside tap*

**Task:** Repair

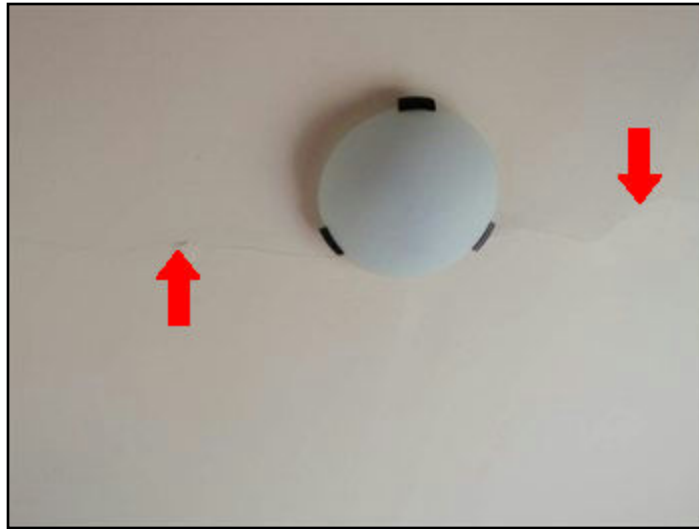
**62. Condition:** • Cracked

*Ceiling crack*

**Task:** Monitor for deterioration

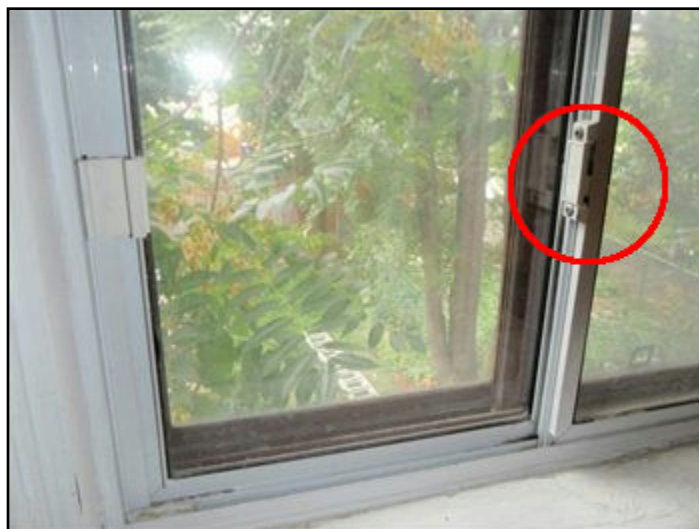
*Broken latch. Note exterior pane backwards*

**Task:** Repair

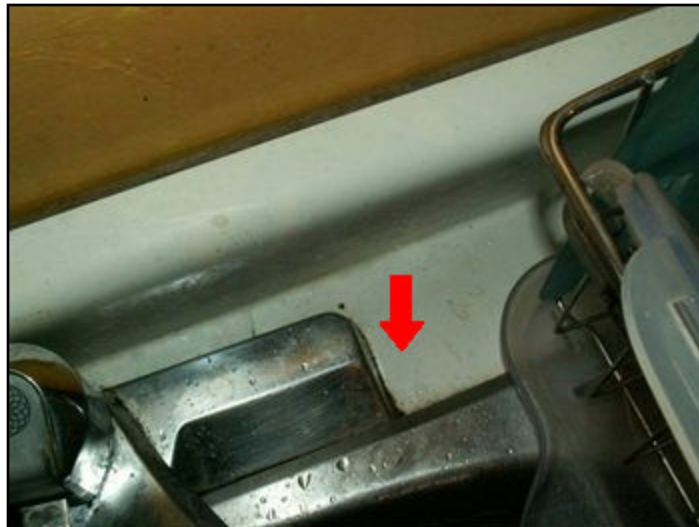
*Counter sagging under tap*

**Task:** Replace counter

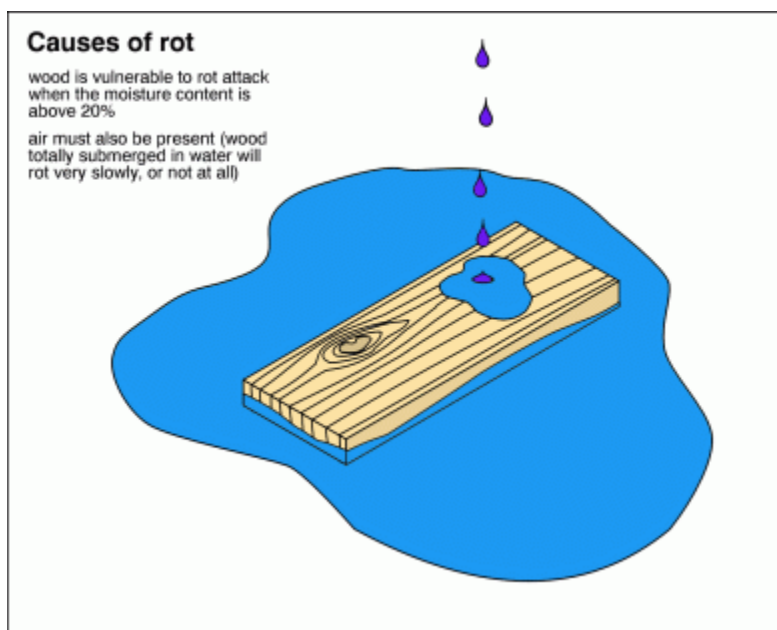
### 70. Condition: • [Rotted substrate](#)

**Task:** Replace

**Time:** When remodelling

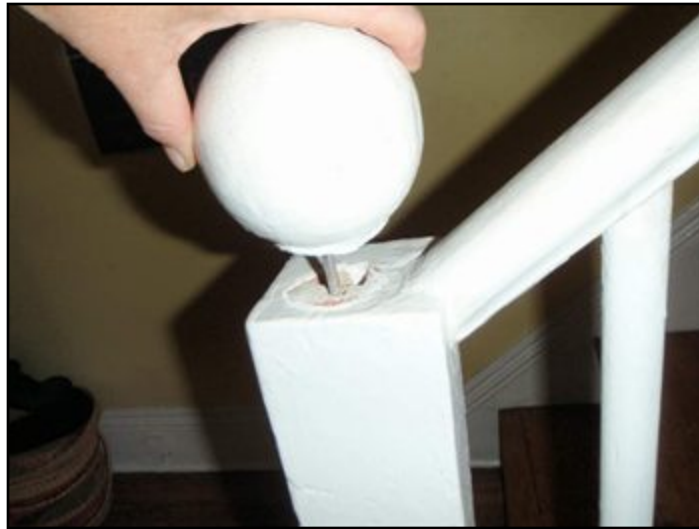
*Loose baluster top*

Task: Repair

Time: Immediate
