# INSPECTION REPORT

For the Property at:  
**321 TYPICAL STREET**  
TORONTO, ON

Prepared for: VALUED CLIENT  
Inspection Date: Tuesday, October 2, 2012  
Prepared by: Lisa Simkins

Report No. 1016, v.3

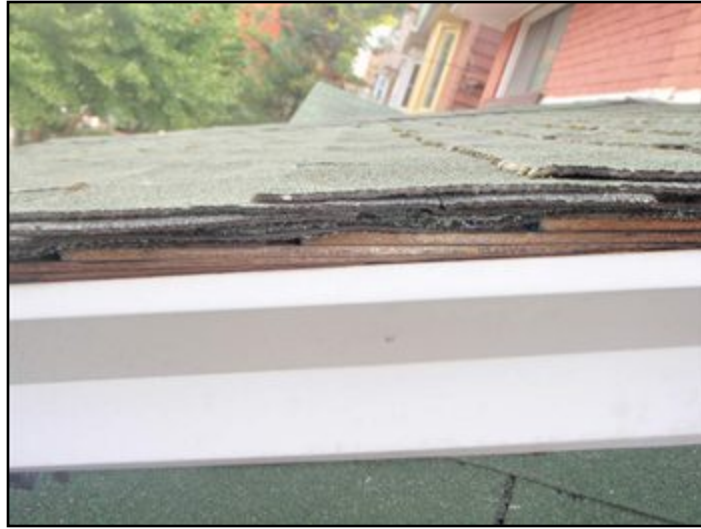
*Layers of roofing over front porch*

- [Strip when reroofing](#)

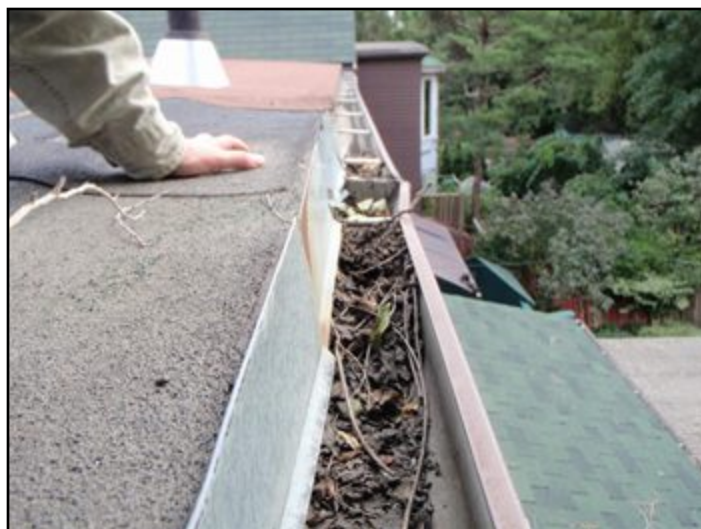
7. Condition: • [Clogged](#)

*Clogged rear eavestrough*

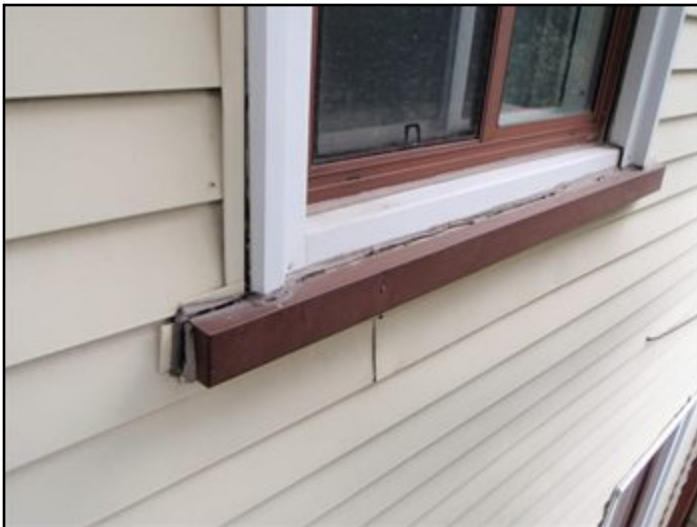
**10. Condition:** • [Flashing and caulking defects](#)

*open joints around frames*

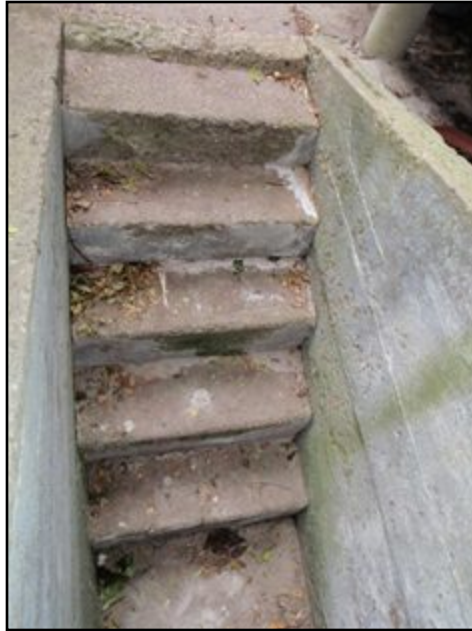
## 21. Condition: • [Guard and handrail problems](#)

missing

*No handrail in basement stairwell*

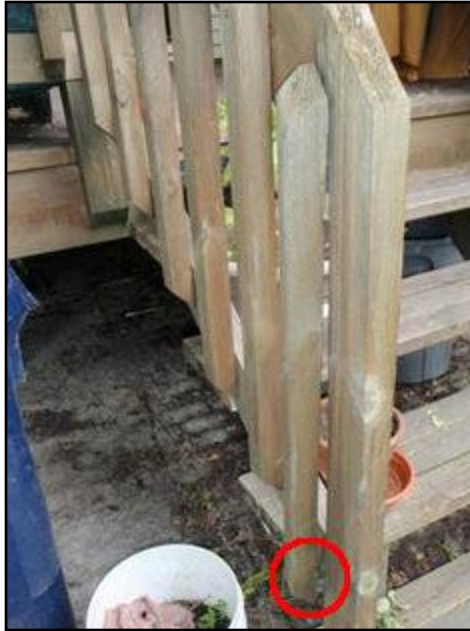
*rear porch nails coming out of support*

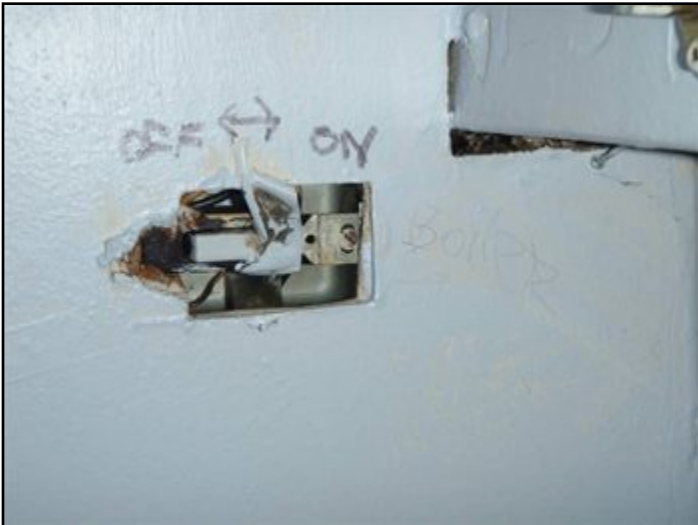
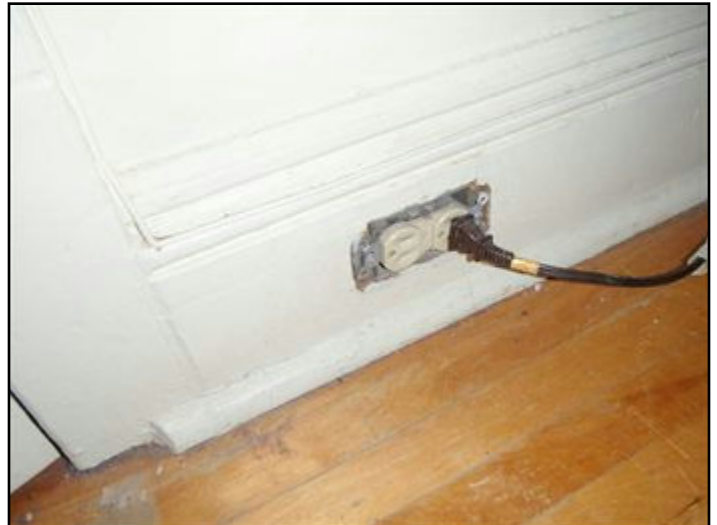
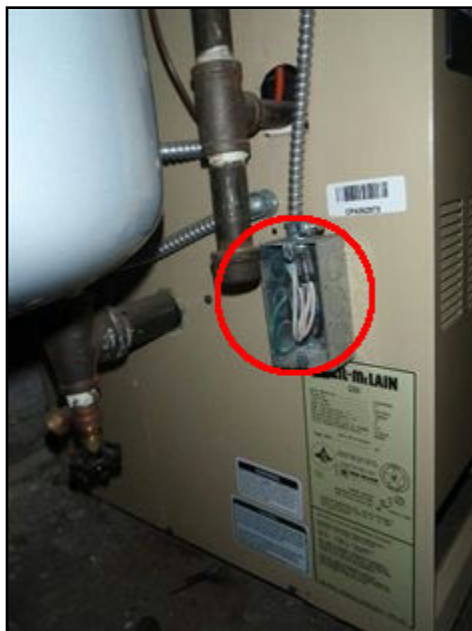
Basement ceiling switch

Upstairs Bedroom receptacle

Boiler electrical box

**Task:** Install plates

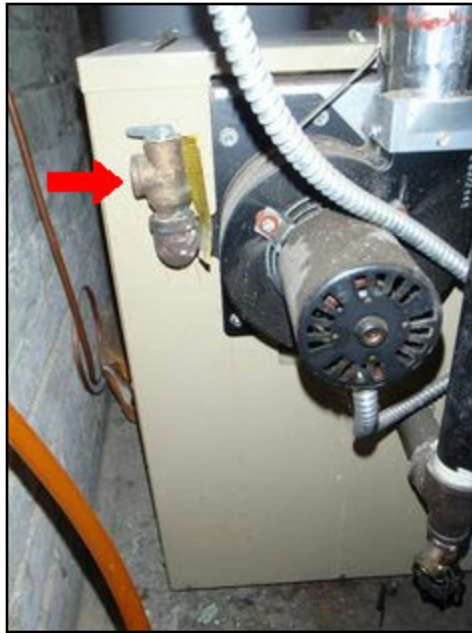
*No pipe extension*

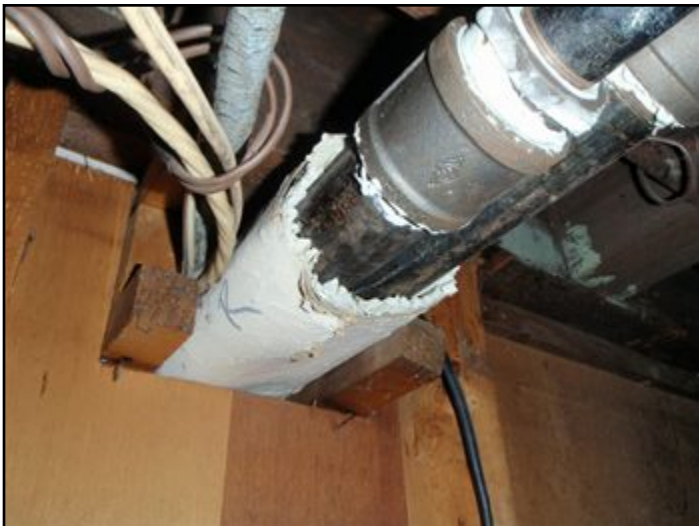
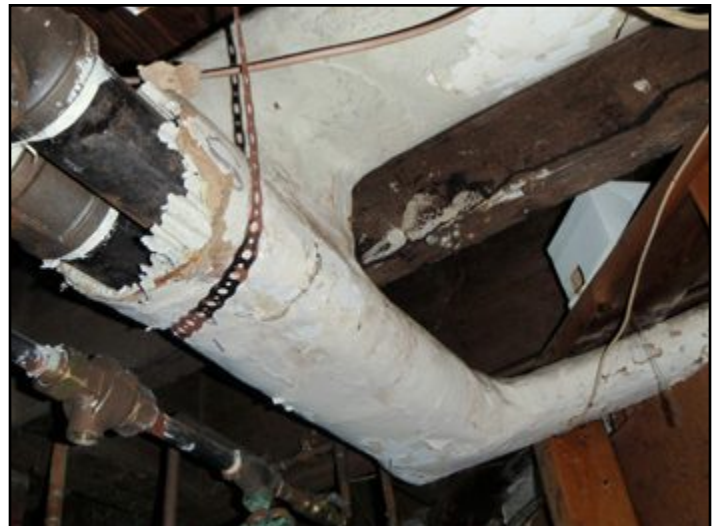
*Boiler water pipe wrap partially removed*

*Boiler pipe wrap*

**Task:** Encapsulate or remove wrapping by asbestos removal experts

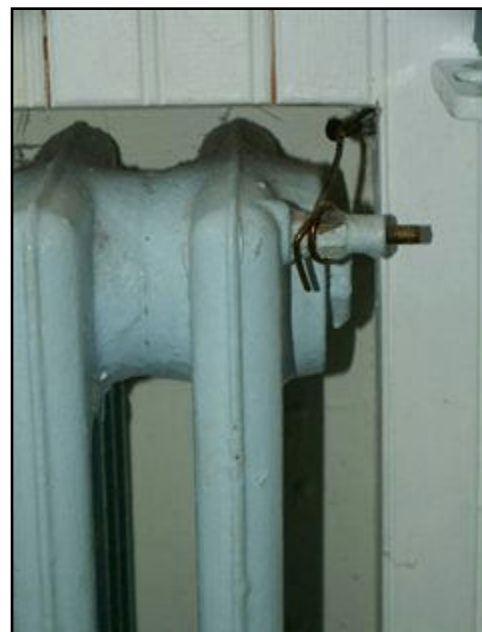
*Rad legs poorly supported*

*Tied to wall with wire*

**Task:** Improve

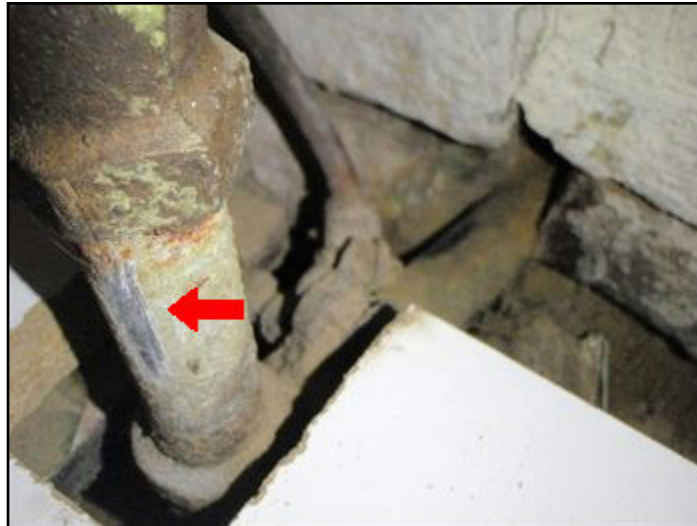
The main supply pipe appears to be galvanized, and may be causing low flow in the house. Recommend replacement with copper supply pipe from the city piping to the meter. Several minor repairs of piping and fixtures are recommended.

Scraping of pipe surface upstream of meter shows a grey surface which appears to be galvanized steel. This area is difficult to access.

*Galvanized steel*

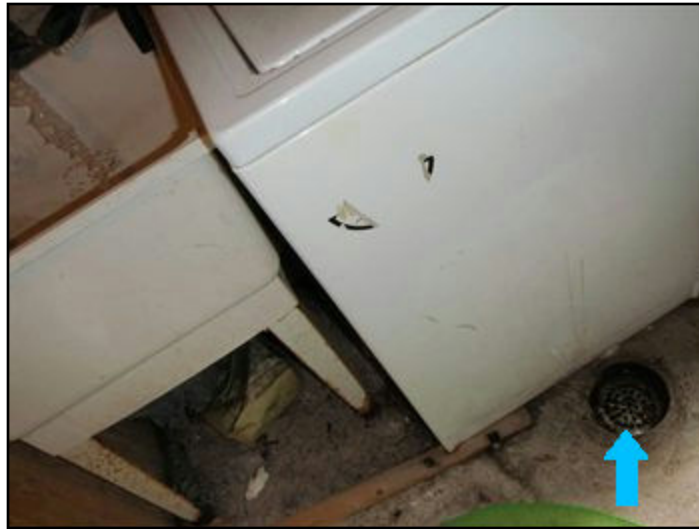
*Floor drain*

**Task:** Make sure drain is exposed at all times.

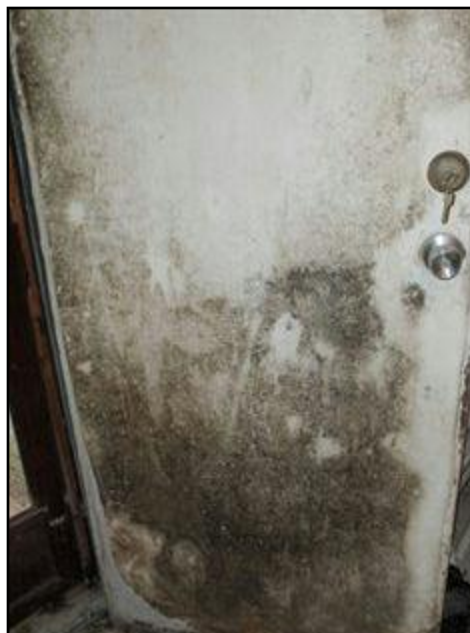
### 66. Condition: • Mildew

**Implication(s):** excess moisture and/or lack of air circulation

**Location:** Basement Laundry Area

**Task:** Improve

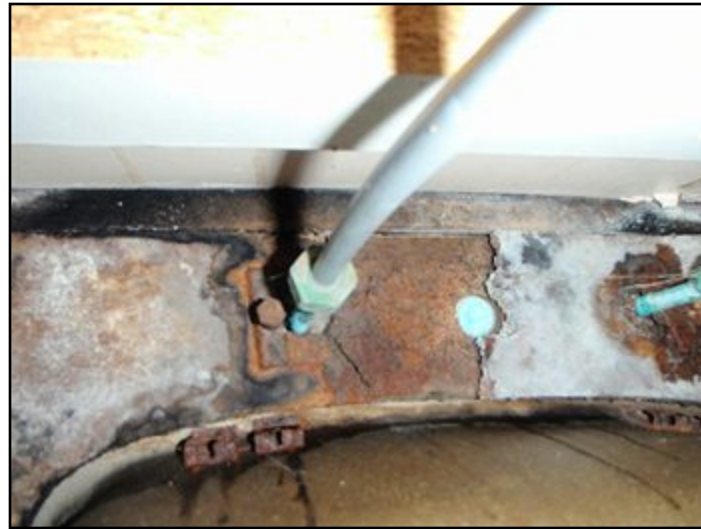
### 70. Condition: • [Rotted substrate](#)

Water damage to counter at kitchen sink taps

*Rotted counter under kitchen sink*

**Task:** Replace
